Docket No. 217 – Development and Management Plan Inspection

Northeast Utilities Service Company Certificate of Environmental Compatibility and Public Need for the construction of a 345-kV electric transmission line and reconstruction of an existing 115-kV electric transmission line between Connecticut Light and Power Company's Plumtree Substation in Bethel, through the towns of Redding, Weston, and Wilton, and to the Norwalk Substation in Norwalk, Connecticut.

Date: April 26, 2005

Location: 345kV XLPE Component

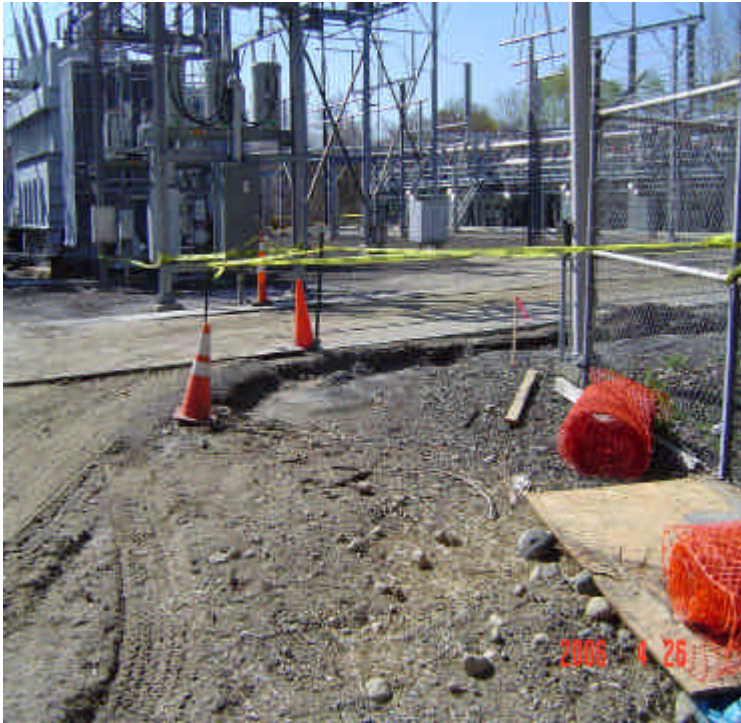
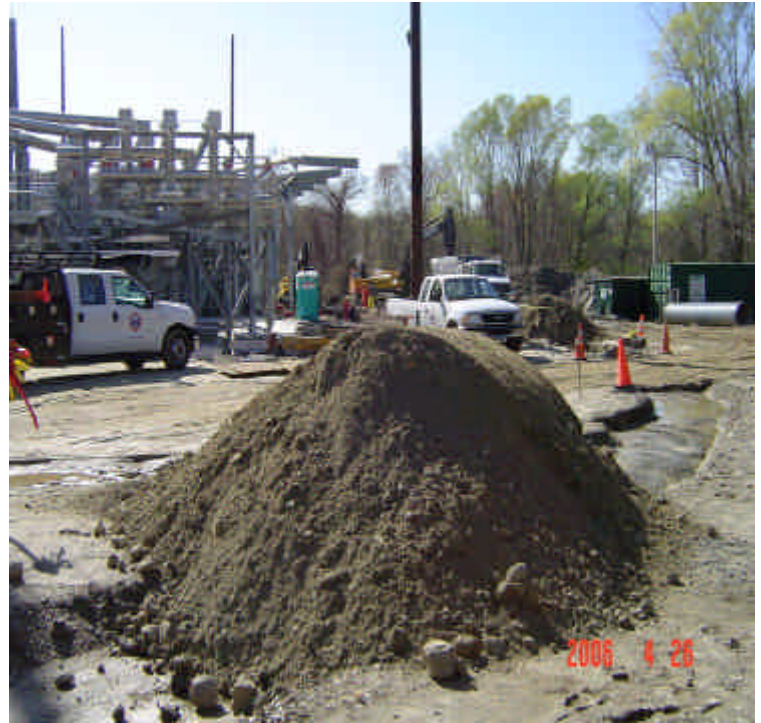
345kV XLPE (Plumtree Substation): Both photos show the active excavation and trench work for this project within the station yard. All soil and work remains contained at this time. 4/26/06

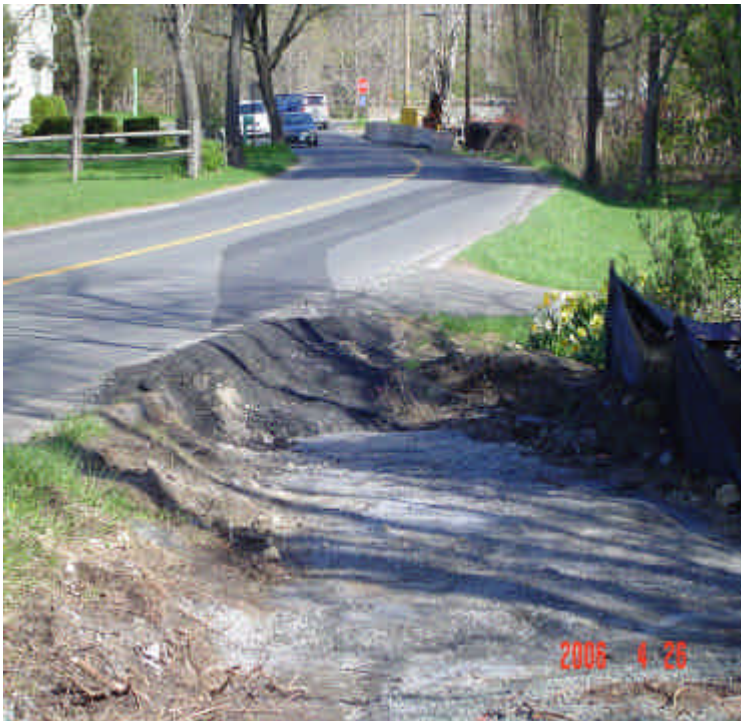
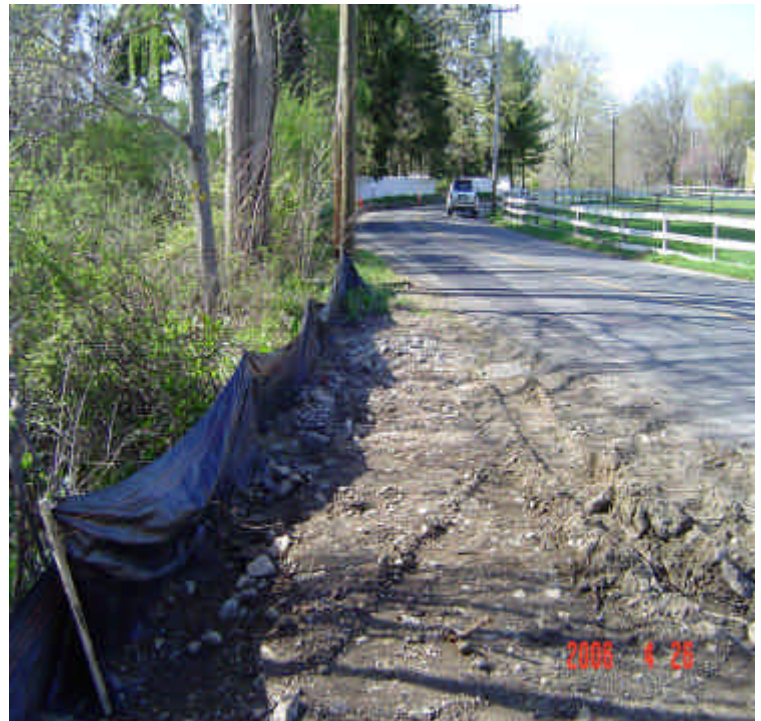
- Work is complete near vault 2A&B. Silt fence is	- Restore when feasible and keep stone surface to	-Needs attention when feasible

(Walnut Hill Rd) Both photos show the completed trench leading from the pull-off area at vault 2a and 2b to the roadway. Silt fence was extended on both sides as recommended. 4/26/06

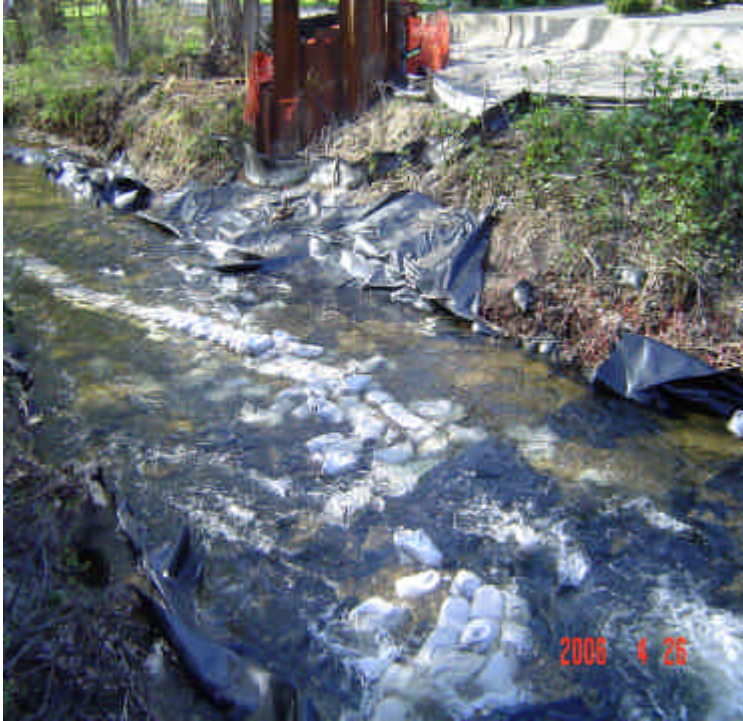
- One inactive filter bag remained behind the silt fence. 4/26/06	-Upon restoration, remove all materials including filter bags. 4/26/06	-Needs attention when feasible
	-The plastic liner remains within the stream bed. The recent heavy rains and increased flow scattered the sandbags in the diversion area. 4/26/06	-The stream was still running clear at the time and will be restored eventually. Water problems in the trench continue and the sandbags will be restored. 4/26/06	-N/A at the time
	-Silt fence was restored at the receiving pit side. 4/26/06	-None at this time-continue to monitor 4/26/06	-Silt fence was restored.
Judd Ave	-Dewatering was noted to a filter bag near the trench work at vault 5 and the adjacent catch basin was protected. 4/26/06	- The area was well contained with good controls. 4/26/06	- N/A – proactive controls installed.
Hoyts Hill	- Noticeable grass growth continues along the slope. 4/26/06	- None at this time, continue to monitor for stabilization. 4/26/06	- N/A (grass growth has occurred)

(Jack and Bore) Photo on the left shows the diversion work in the stream where sandbags were washed out of place due to the recent heavy rains. Photo on the right shows a view of the bore pad. 4/26/06

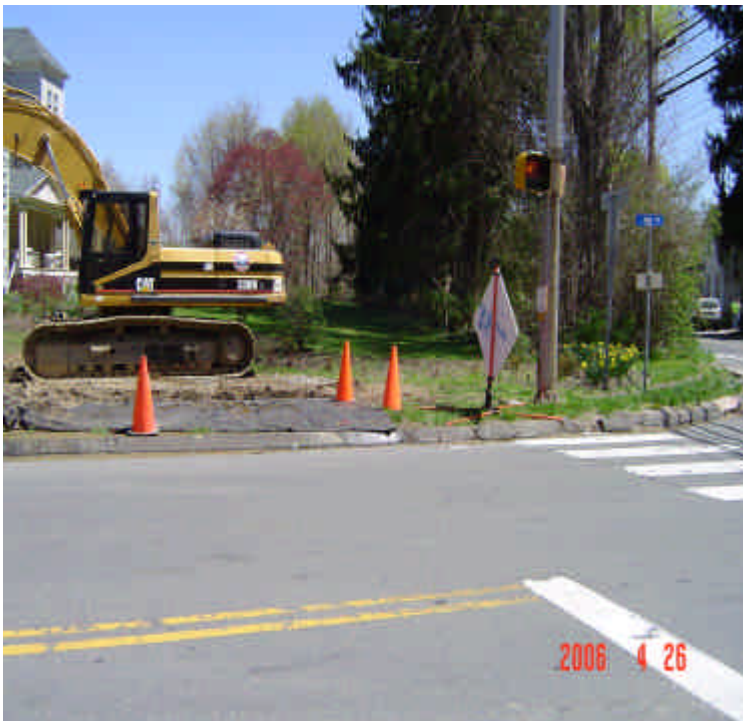
(Judd Ave and Hoyts Hill): Photo on the left shows a view of the work near vault 5. Dewatering was being sent to a filter bag and then a protected catch basin. Photo on the right shows a view of the remaining open trench at Hoyts Hill some tracking was present off the stone pad in the adjacent wetland. 4/26/06

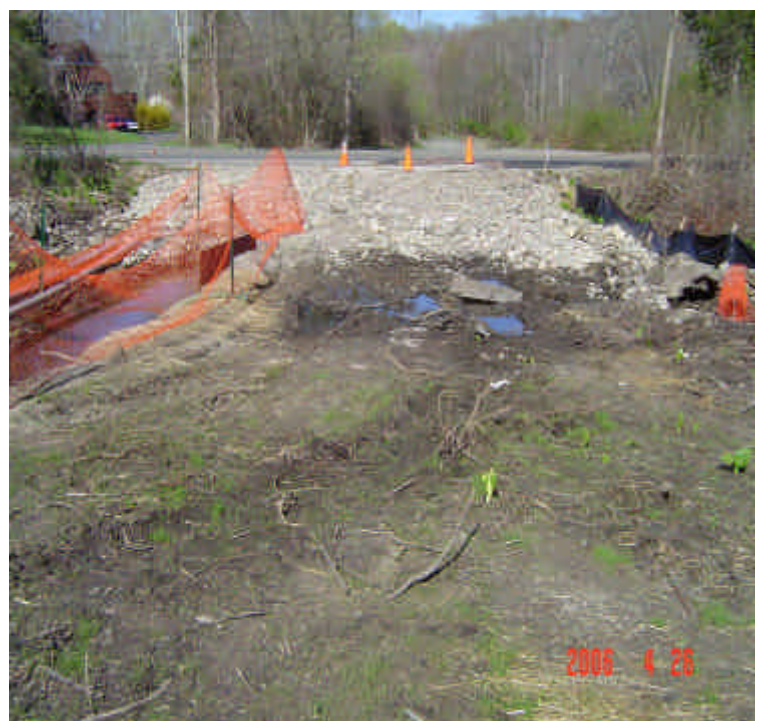
-Equipment tracking was noted in the wetland beyond the stone access where mats had previously been. 4/19-4/26/06	- Mats may have been removed prematurely. The wetland surface should be restored when work is complete. 4/19-4/26/06	-Needs attention
Inland Wetland and Watercourse encroachment and mitigation	-East Swamp Brook crosses under Plumtrees Rd. A large plastic liner is in place across the bed and up along the banks to keep water out of the bore trench. Sandbags were scattered due to the recent high flow. 4/26/06 -Water problems continue in the trench.	- The stream continues to run clear. Be sure to remove the liner and restore the natural bed when work is complete. Watch the banks where soil was disturbed for any erosion. 2/16-4/26/06	-N/A at this time until the work is complete
